RADAR SLOPE MANAGEMENT AT NCHANGA OPEN PIT MINE ZAMBIA: FOOTWALL FAILURE OF NOVEMBER 2014

S Silwamba C^{1*}, Chileshe P R K²

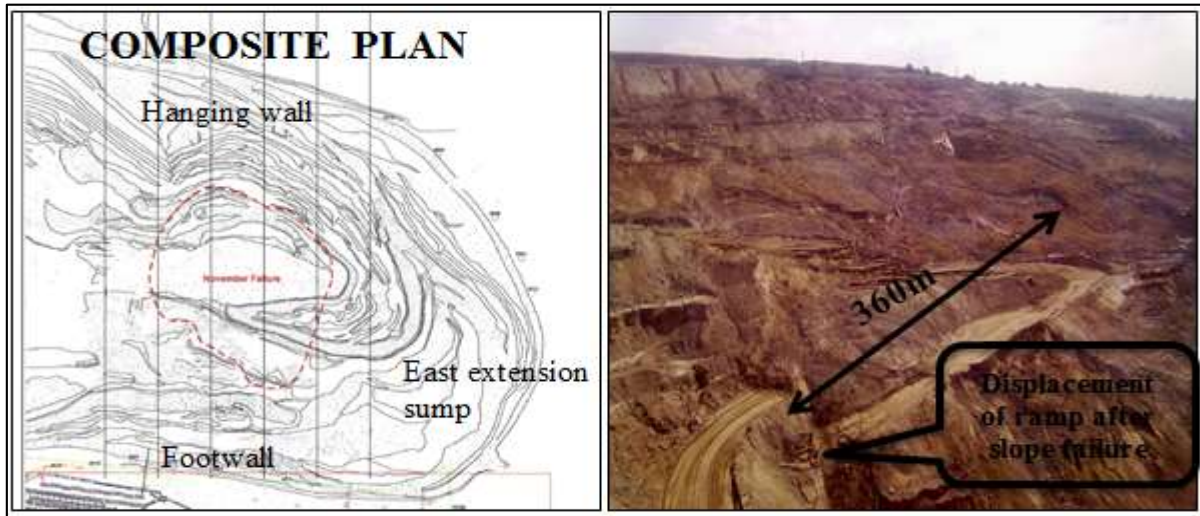
The footwall slope failure of the Nchanga Open Pit of 14 November, 2014, NOP CUT-II, occurred between section lines 32East and 35East, covering a strike length of about 360m and affected benches from 135mb to 210mb. Approximately nine hundred thousand tonnes of sloughed back fill material of the footwall came down on the extreme eastern side of the pit and resulted in three 240t Komatsu 830E trucks being partially buried. There were no personal injuries although the incident had the potential to affect quality of life and was declared by the company, Konkola Copper Mines Plc (KCM), as a HIPO, i.e. high potential with ability to affect quality of life. Figure 1 shows the slough zone, while Figure 2 shows the partially trapped Komatsu trucks after the slough.

Figure 1: Plan and pictorial view of Nchanga Open Pit Slough zone of November 2014

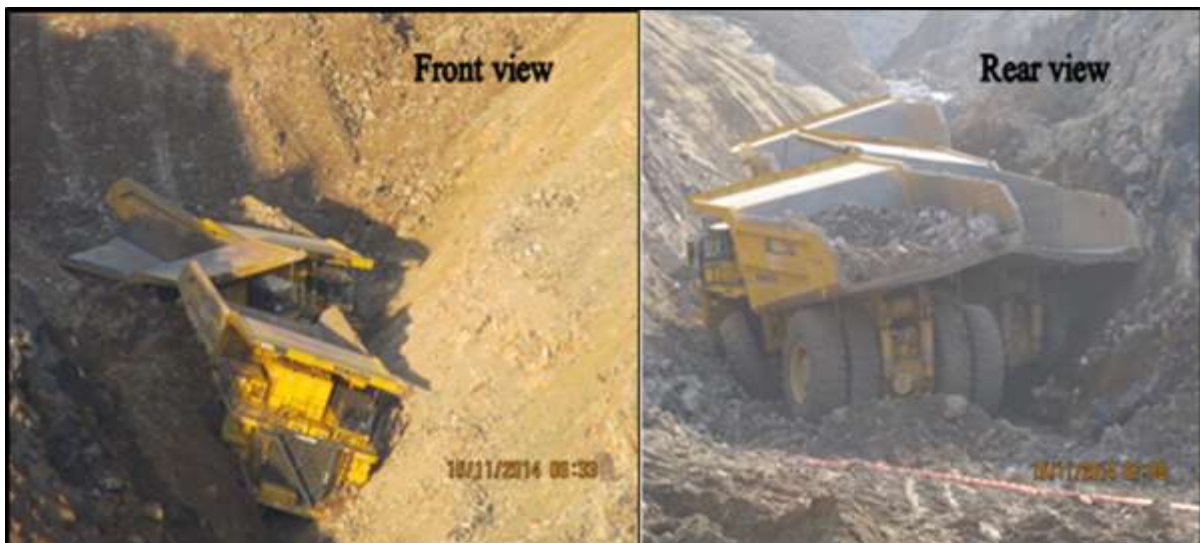
Figure 2: Three 240t Komatsu 830E trucks partially buried after the slough at Nchanga Open Pit

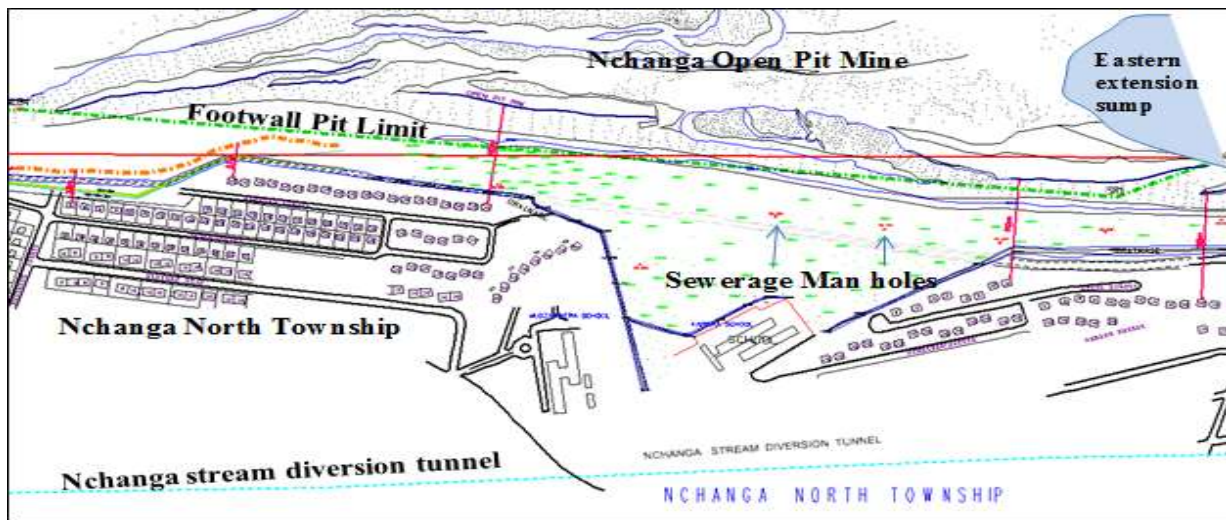
Nchanga Open Pit mine which derives its name from the Nchanga stream which initially ran across the current location of the pit and was diverted further south in a stream diversion tunnel called WD3 in 1972, to pave way for mining as shown in Figure 3 (KCM Survey Department, 1999). Over the years, this tunnel had not been inspected to check the integrity of the concrete lining walls. Recent attempts to gain access into the tunnel proved futile. Indications are, however, that deposition of silt accumulation has reduced the tunnel initial opening of about 5m to approximately 0.6m.

Figure 3: Nchanga stream diversion tunnel (KCMSurvey Department,2014)

The alternative would be to de-silting the stream diversion channel and inspecting the integrity of the channel lining for mitigation measures. It must however be noted that ensuring continuity in the flow of water inside the diversion tunnel was unquestionable, as otherwise the mine would flood.

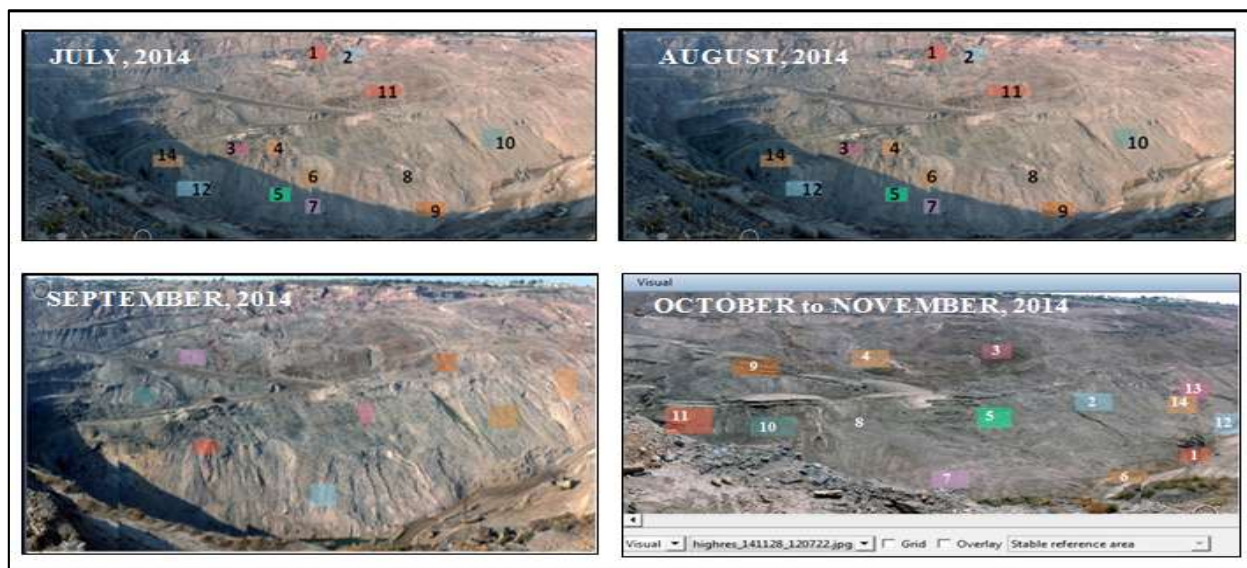
Deformation rates data, month by month, five months prior to the failure was further collected and analysed for indications of slope instabilities. A summary of these rates by pictorial views are shown in Figure 5 while location points were shown in Figure 6 prior to failure

Figure 5: Pictorial view of deformation rates locations points –July to November 2014

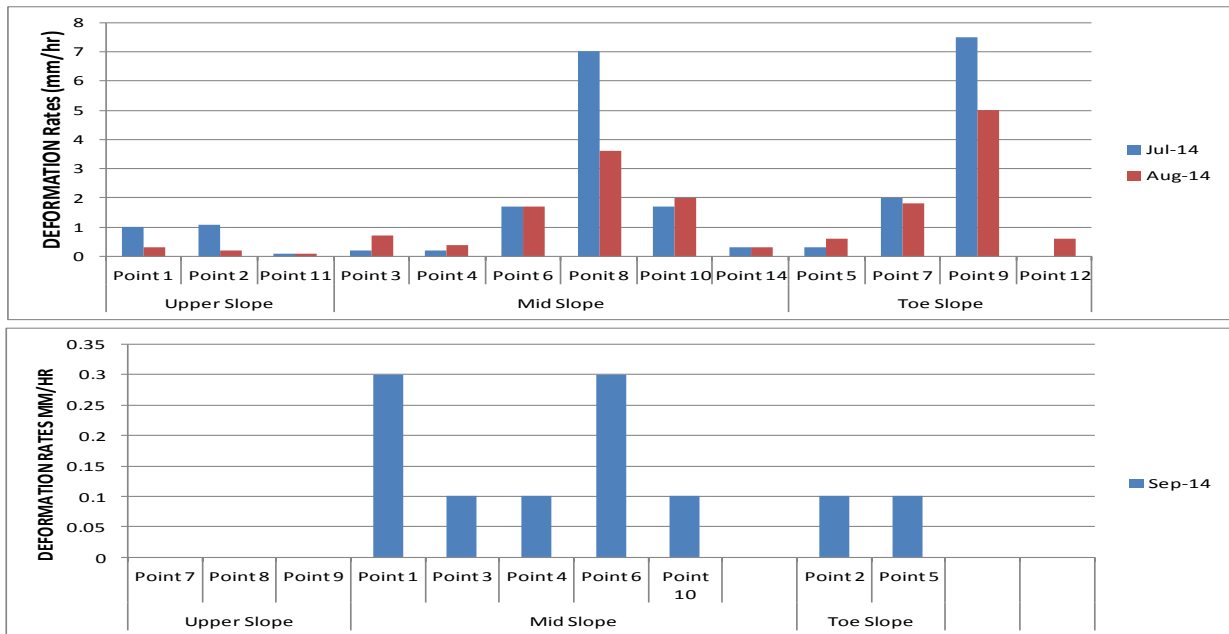
From Figure 6, it was noted that in the period July to September 2014, monitoring points in the toe and the mid-slope were very active, compared to the upper slope. July 2014 had the highest activity while August 2014 saw a decline which continued through September 2014

Figure 6: Deformation rates on the south footwall slope at Cut II Nchanga Open Pit July – September 2014

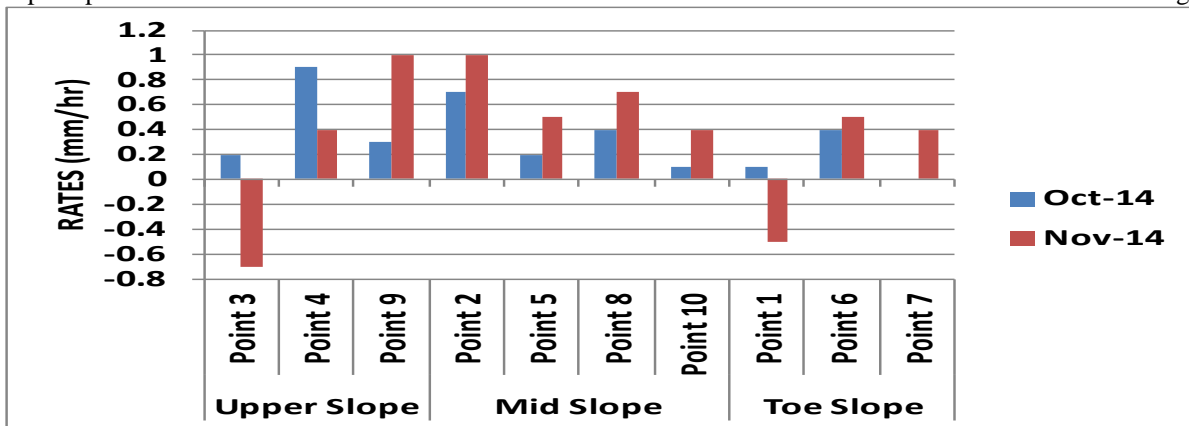
In October and November 2014, the activity was insignificant (Figure 7) across the upper, mid and toe slopes, but interestingly there was a perceptible increment from October to November 2014 in the toe deformation rates in the month of the slough.

Figure 7: Deformation rates on the south footwall slope at Cut II Nchanga Open Pit October – November 2014, just before the failure

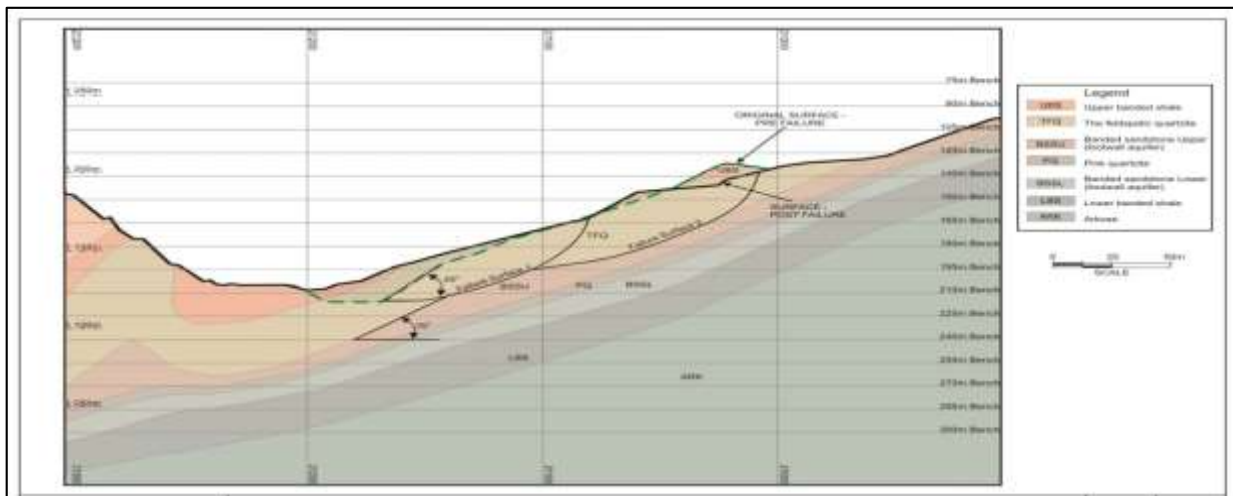
The pattern of deformation showed a lesser degree of deformation in the upper portion of the slope while a larger degree of movement was taking place at the toe and the mid-slope, suggesting a **two phase failure mechanism (Figure 8)**. Overall ground movement rates across the whole slope, were relatively small, less than 1 mm/hr, in the two months before the failure (Figure 7). The toe of the slope went first followed by the mid and upper portions of the slope as postulated in Figure 8. The low deformation rates in the period of October and November before the slough seems to indicate a stick-slip scenario, whereby the slope had experienced intense activity in July and August 2014 (Figure 6), and then stuck, leading to a quiet period. This same pattern had been observed earlier on in the year in April 2014, when there was a lot of activity followed by quiescence. On the day of the slough, 14th November 2014, a trigger of some kind, possibly the early rain seepage as shown in the appendix (Table VII) and Table V, little as it may seem, or blasting further accelerated the massive ground movement over just a few hours, which

Figure 8: Two phase failure mechanism of Nchanga Open Pit Foot wall slope (Terbrugge, 2015)

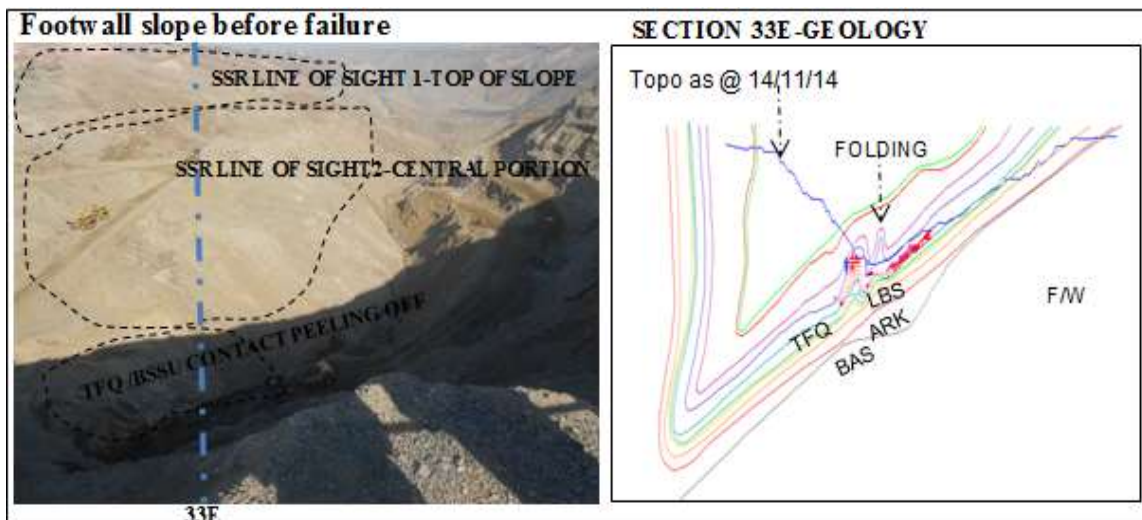
coincided with the SSR® ‘information blackout’. The slope movement then stuck again, as found after the slough, whereby the trucks at the toe could even be rescued, and were not completely buried (Figure 2). The folded nature of the rock formations at the bottom of Nchanga Open Pit enhanced this failure mechanism due to the fact that the rock strata after being exposed ‘day lighted’ in the face as shown in Figure 9.

Figure 9 illustrates the zones outside the radar coverage for deformation calculations and geological folded nature of section 33E.

Figure 9: Footwall slope and geological nature of section 33E before failure

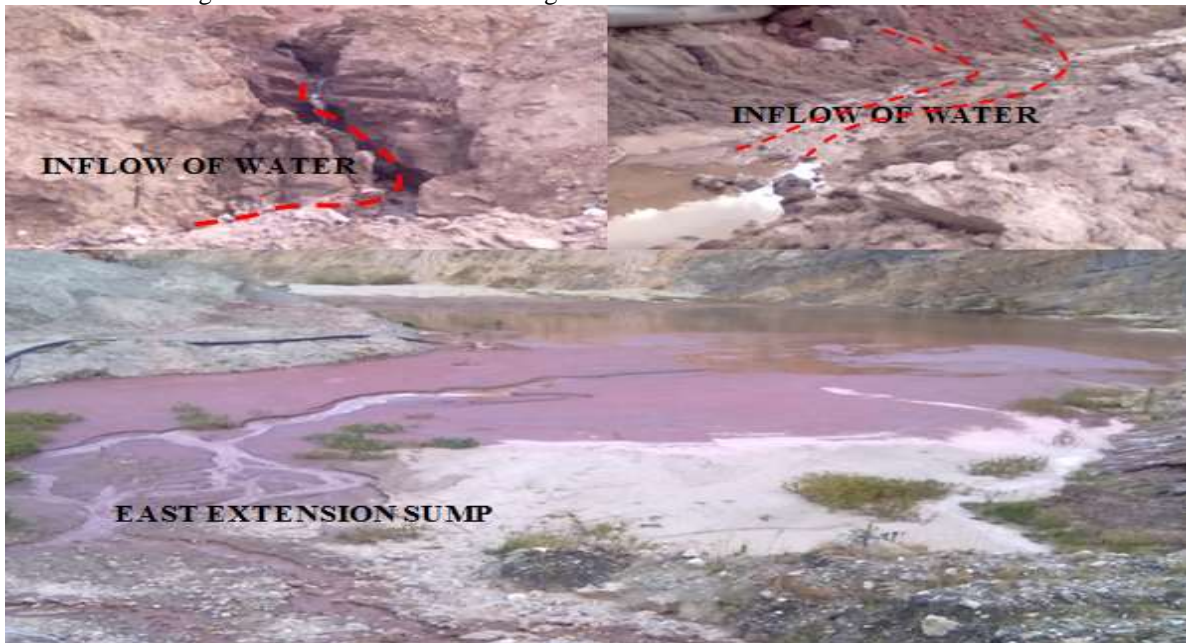
From the surface of the south wall pit limit to about 30mb of the Nchanga Open Pit mine slopes, there was a continuous ingress of surface water as shown in Figure 10. From inception of Nchanga open pit mine, rock slope instability of the foot wall side of the mine has been as a result of the 20% effect of the water causing 80% effect on the slope instability. The source of this water is from three perspectives:

1. Unmaintained Nchanga stream diversion channel;
2. The unmaintained man hole and sewerage drains servicing the nearby Nchanga North Township; and
3. Rain water accumulating in the fine rock mass and acting as a lubricant.

Figure 10: Sub - surface water percolating through the NOP Foot wall slopes (top) and the Eastern Extension sump

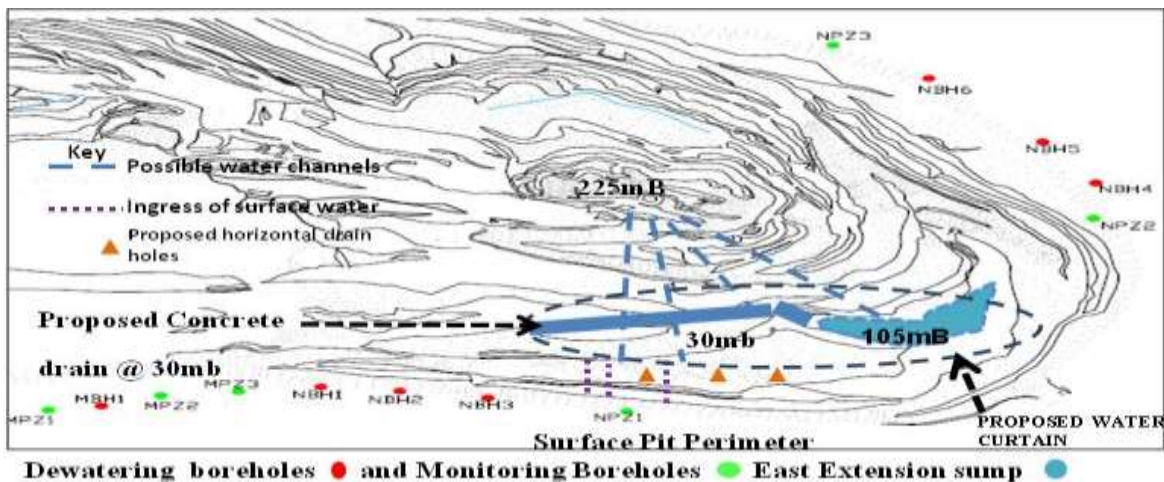
Figure 11: Pit layout and boreholes in the East of Nchanga Open Pit

From the practical point of view, creating a ‘water curtain’ (Figure 11) for the sub - surface water would have a huge impact on the stability of south wall at Nchanga Open Pit foot wall compared to the complementary options of resolving the primary root causes of the water from the diversion stream. SRK Consulting was key in assisting with the formulation of a strategy (Terbrugge, 2015). The fatal slope failure of 2001 established clearly the influence of water on slope stability at Nchanga.

1. Mining out all the weak BSSU to the PQ plane to enable tracing of the water transportation causing slope instability.
2. Creating a deep concrete lined curtain drain along the foot wall with the objective of capturing all the water and directing it to controlled sumps.
3. Drilling of horizontal de-pressurizing boreholes from the foot wall into the concrete drain.

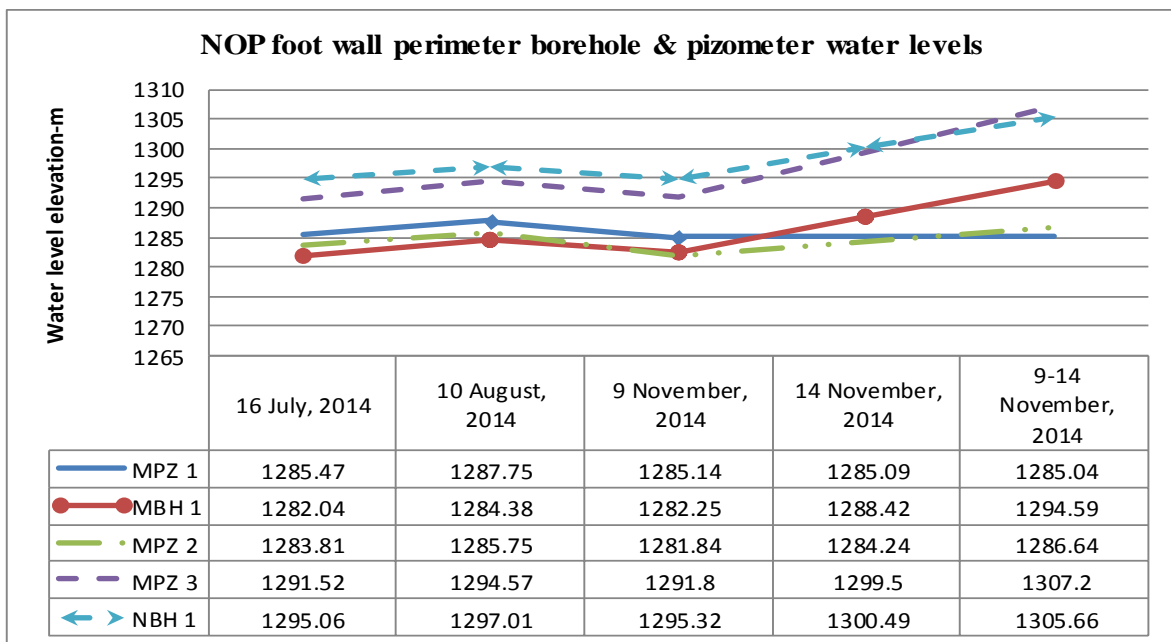
A trend analysis of the monthly water levels of the south wall pit limit bore holes was carried out as shown in Figure 12.

Figure 12: NOP calculated South wall water profile

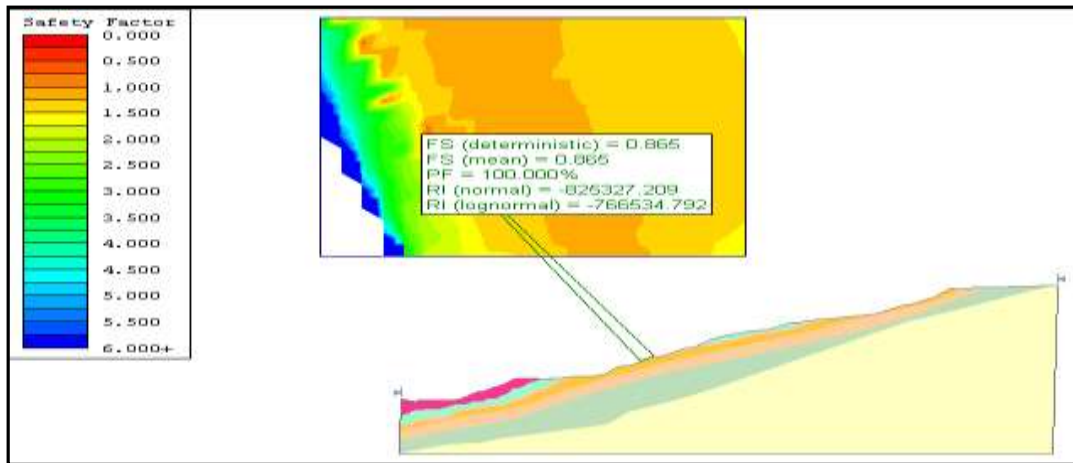
A 15 to 20m middling between the top of the mined TFQ rock mass horizon and the BSSU contact at the bottom of the pit compared to a 50m middling higher up on the western side of the failure was left to anchor the foot wall slope. This is coupled with an increase in the dip angle of the mined slope from 30° to 35° on the TFQ/BSSU contact near the 33E section and the folded nature of the rock mass accelerated the slope failure in a two phase mechanism as depicted in Figure 13.

Figure 13: Impact of water on foot wall slope on Section Line 33.5 @ $H_u = 0.4$

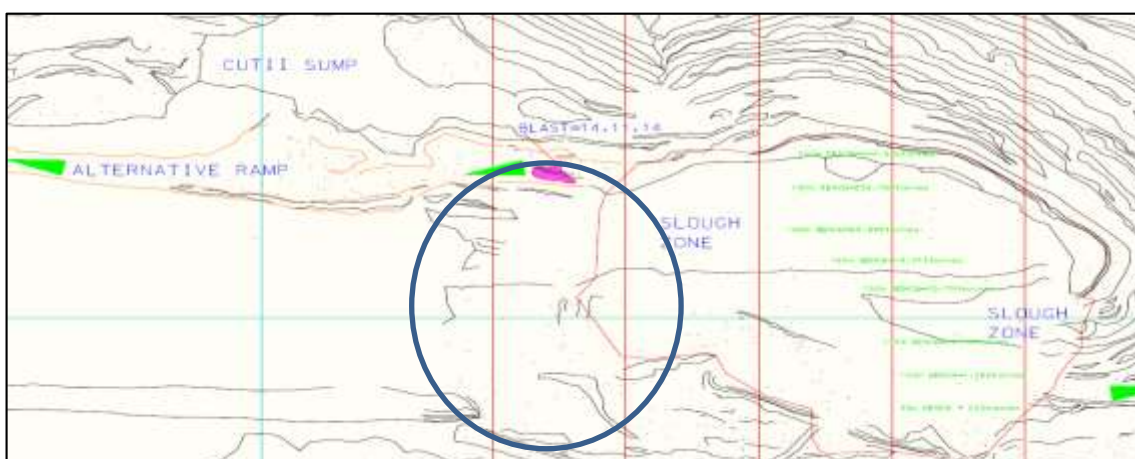
On the day of the slough at about 16:30hrs, a blast was conducted at the bottom of the pit on the access ramp to re-profile the western access. This was to ensure natural flow of rain water into the prepared sump for the rain season, which meant that the second access route into the pit was temporarily closed because of the blasted material (Figure 17).

Figure 17 illustrates the relationship of the slope zone to the area blasted before failure.

Figure17: Blast of 14th November 2014 in relation to Failure zone (circled)

5. Moreover, it could be concluded that though the blast on the day of failure happened 720m away from the failure zone, it might have played a role in accelerating the deformation of the slopes which eventually ended up failing on the 14th November 2014 in combination with other factors such the ingress of sub - surface water.
