RADAR SLOPE MANAGEMENT AT NCHANGA OPEN PIT MINE ZAMBIA: FOOTWALL FAILURE OF NOVEMBER 2014

S Silwamba C^{1*}, Chileshe P R K²

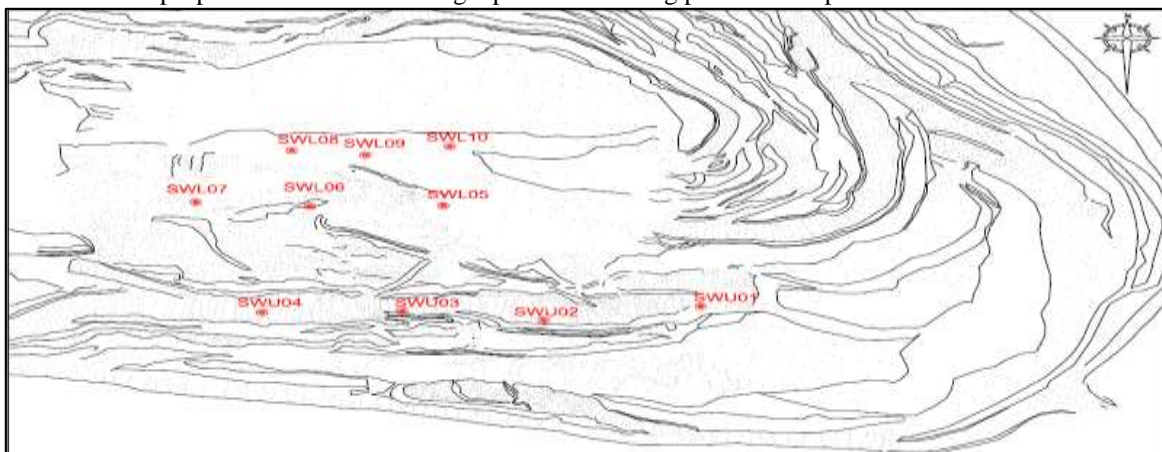
Fig 16: NOP CUTII Foot wall slope location of prisms for survey monitoring of deformations

Figure 16 illustrates the proposed location of the target prism monitoring points for displacement calculations.

The SSR® which works by principle of line of sight could not capture the excessive displacements at the toe of the slope with increase in depth of the pit (210mb). This is attributed to the fact that the mine site relies on the instantaneous 2-D deformation rates component of the SSR®. A 3-D analysis of the deformation vectors with the application of survey monitored pegs as shown by the example of survey prism in Figure 15 and associated prism location plan in Figure 16 could be used to predict and mitigate slope failures at NOP.
